Service Information Letter: SIL-DK180-2020-001

LOW FREQUENCY UNDERWATER LOCATING DEVICE (LF-ULD)

DK180

<h1>Service Information Letter</h1>	Doc No. SIL-DK180-2020-001
	Rev B
	Date: 10Feb2020
SUBJECT: LF-ULD's Manufactured with Suspected Counterfeit Parts

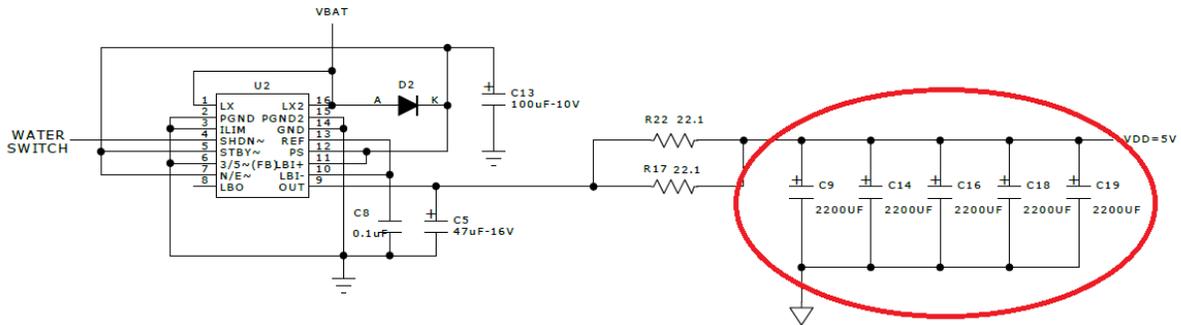
The DK180 utilizes five (5) parallel bulk storage capacitors on an internal 5Vdc voltage rail used to power its piezo ceramic transducer. The capacitors, part number UVK1A222MPD, are 2200uF Aluminum Electrolytic devices manufactured by Nichicon. An excerpt from the electrical schematic showing these devices is provided below:

In all ten (10) of the returned DK180s that presented these symptoms, it was confirmed that one of the five bulk storage capacitors within each ULD had failed in a short circuit condition, preventing power from reaching the transducer. The failed UVK1A222MPD capacitors appear not to have been manufactured by Nichicon.

1. Current operators of affected DK180 LF-ULD’s referenced in Paragraph A above are encouraged to replace the device from service per the following recommendations:
 - a) Contact Dukane Seacom directly via email address DK180@rpcaero.com. This dedicated email address has been setup for managing this Service Information Letter. When responding, please provide a list of your affected DK180 Serial Numbers as well as the contact information you would like used for this activity.
 - b) Dukane Seacom customer service personnel will quickly respond to discuss options for either replacing or reworking the affected material.
 - i. For reworked units, Dukane Seacom will re-serialize the DK180 to positively identify that the suspected counterfeit parts have been removed from service.
